SHEQual Bulletin “Exploding” Chamber Lid

A potentially serious injury was narrowly avoided at Huntington WTW due to pressure building up in a manhole.

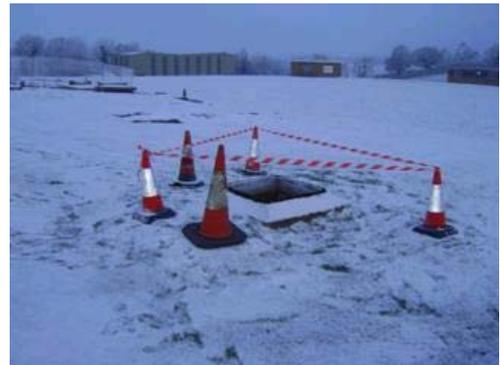
Two Process Controllers attempted to open a manhole where the two sections and the edges of the manhole were frozen. As one of the employees walked away to get some warm water the second employee tapped the edges of the manhole with a lifting bar and ultimately broke the seal. At this point, the whole lid was blown out of the chamber, striking one of the employees and knocking him into the shaft. Fortunately he managed to hold on to the edge of the chamber and avoided serious injury.

The manhole in question is situated on a leg between the first and second stage filters. It appears the pressure build up / vacuum was created due to the ice seal and is of major concern under current weather conditions.

Please be aware of chamber lids around sites that could have the potential to cause a similar issue. This is the first such instance of this type, so please take extreme care around other such installations on your sites. In this instance, the chamber was carrying treated water, but similar occurrences may happen elsewhere.

All defects / issues should be reported to your line manager in the first instance and if the chamber / lid appears unsafe they should be made safe / secure where possible.

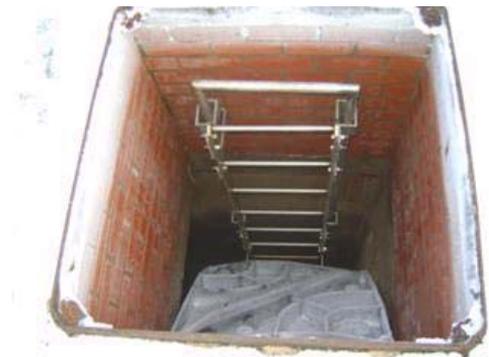
It would appear that the cause of the ‘explosion’ was a build up of air pressure within the chamber. However, the lid had become fixed to its seating and frosted over; this meant that a seal was formed around the lid. When the seal was broken the pressure built up below caused the lid to be blown upwards, before crashing back down onto the open chamber.
