Safety Alert

Queen Mary Reservoir – wall collapse

SA 00262

11th December 2017

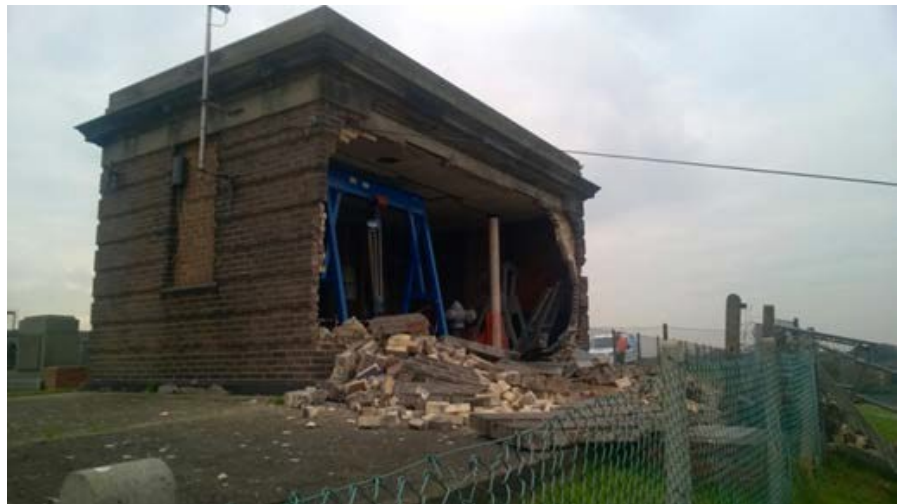
On Thursday 2nd November whilst undertaking a planned valve operation at the Queen Mary reservoir outlet; there was an incident which caused significant damage to the brick valve house located on the crest of the Queen Mary Reservoir.

It is thought that as the valve house was nearly air tight, the sudden compression of air caused by water filling the partially dewatered tunnel and forcing air into the valve house may have potentially caused the north-eastern wall of the building to collapse.

Where existing buildings have been updated or improved, please check ventilation arrangements are adequate and have not been compromised.

If operating valves or rerouting fluids in large partially closed systems check there are adequate spaces for sudden air movements and this includes compression or expansion.

- Check ventilation louvres in walls are not blocked or covered.
- Check open mesh grating floors are secure and not covered.
- Ensure any change to the shaft flooring or valve house structure is preceded with a proper design review.
