Learning Bulletin – Member of Public – Cuts and bruising from falling over

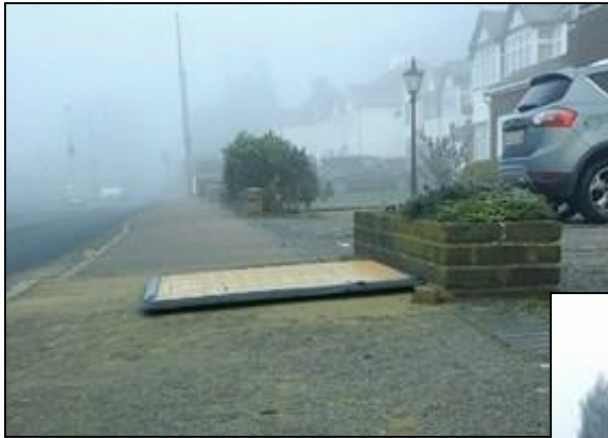
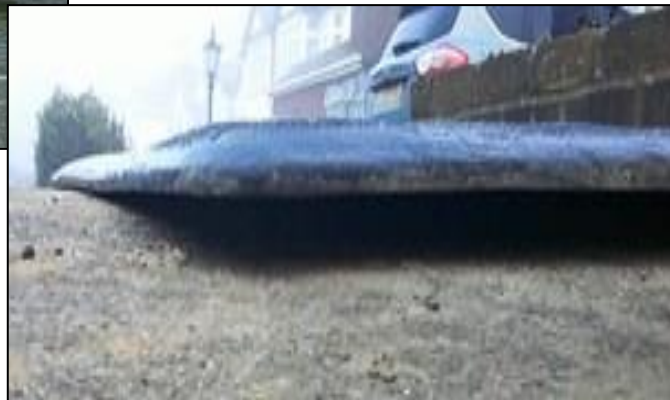
An elderly member of the public narrowly escaped serious injury after tripping on a 'wobbly' footway board and falling to the ground.

A dig team had installed a meter box and backfilled the excavation ready for the tarmac reinstatement the following Monday. The excavation was covered with a rubber edged footway board for the weekend. The footway was uneven and sloped from the garden wall to the roadside gully, which left a trip hazard of approx. 30mm.

- Check to see if boards sit flush, before digging. If okay, proceed as normal
- If boards are 'wobbly' and not obviously bowed or in poor condition, temporary barriers or sand bags are to be placed out, whilst maintaining 1.2m clearance, or as per permit conditions
- If temporary barriers cannot be used, place some temporary tarmac underneath to level out the footway board and make secure.
- Managers & Supervisors are to revisit the site as the team leaves and check that they are secure and take photos if required of the secured footway board
- If the first three cannot be met, a joint inspection is to be carried out with Highway Authority to discuss the condition of the footway and if necessary, abort the dig
